**ANNUAL INSPECTION REPORT  
CLOSED INDUSTRIAL EXCESS LANDFILL (IEL) SITE  
UNIONTOWN, OH 44685**

**BRIDGESTONE AMERICAS TIRE OPERATIONS, LLC  
535 MARRIOTT DRIVE  
NASHVILLE, TN 37214**

**EarthCon Project No. 311001**

**October 15, 2012**

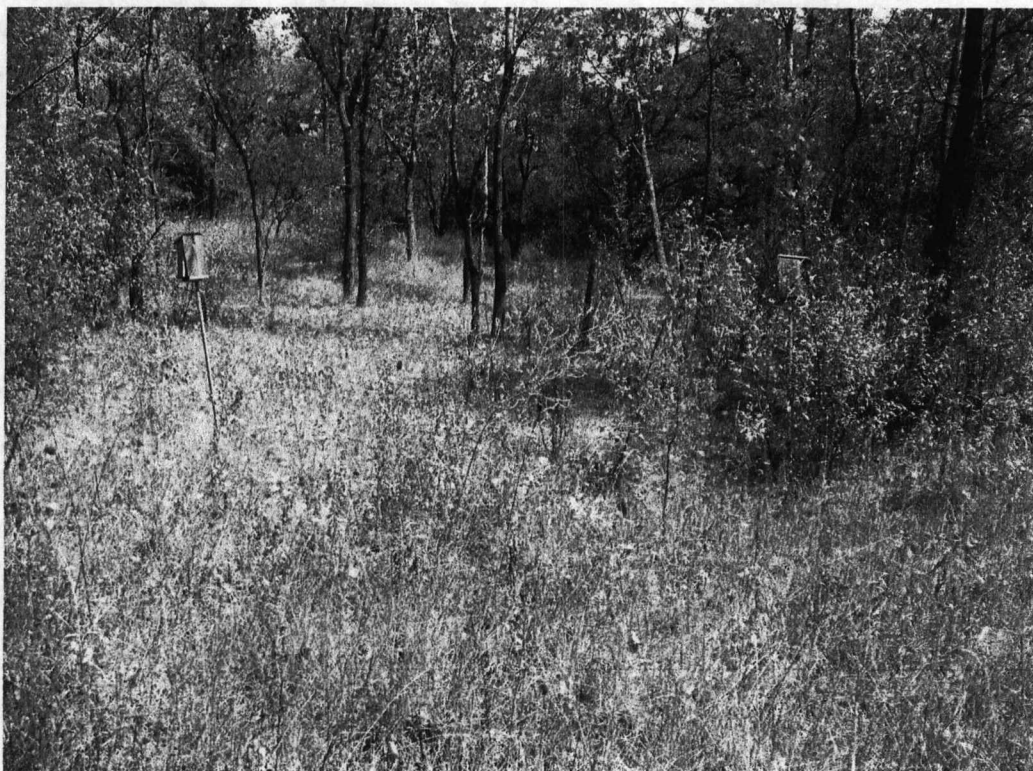
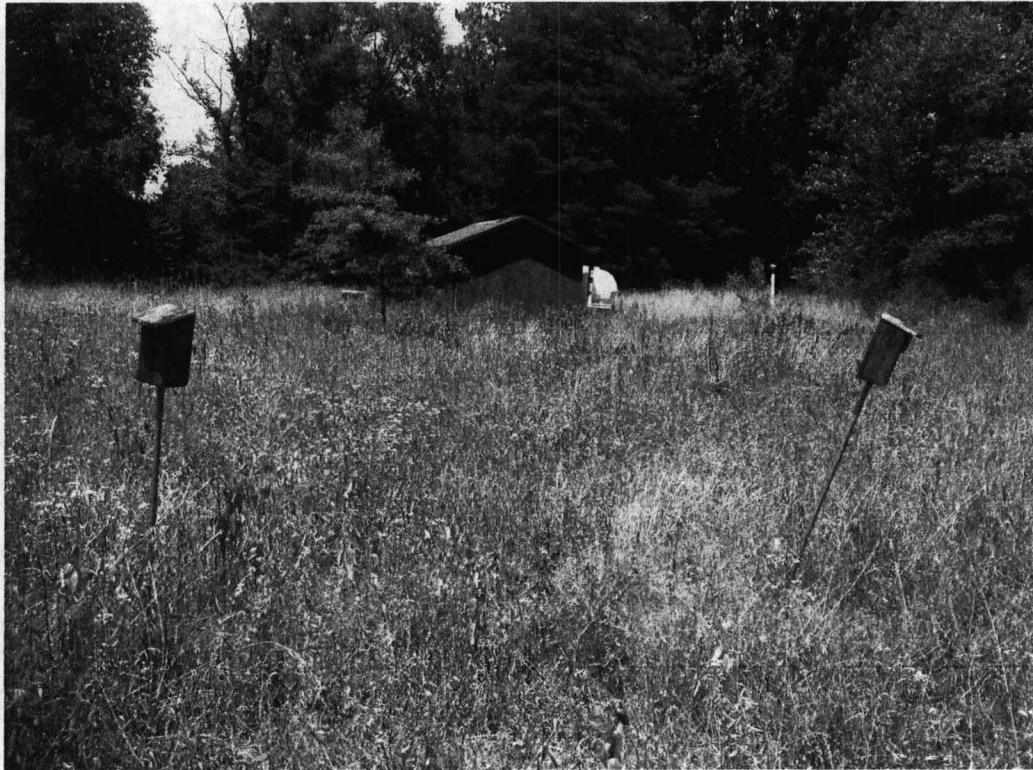
Most (10) of the bluebird boxes were observed. Most are in decent condition, although many of the support poles are tilted and should be straightened. Most of the bluebird boxes appeared to be occupied. The bat condos were not observed- the 15' support pole had nothing atop it. Kestrel boxes were not observed.

Bluebird houses in upper meadow

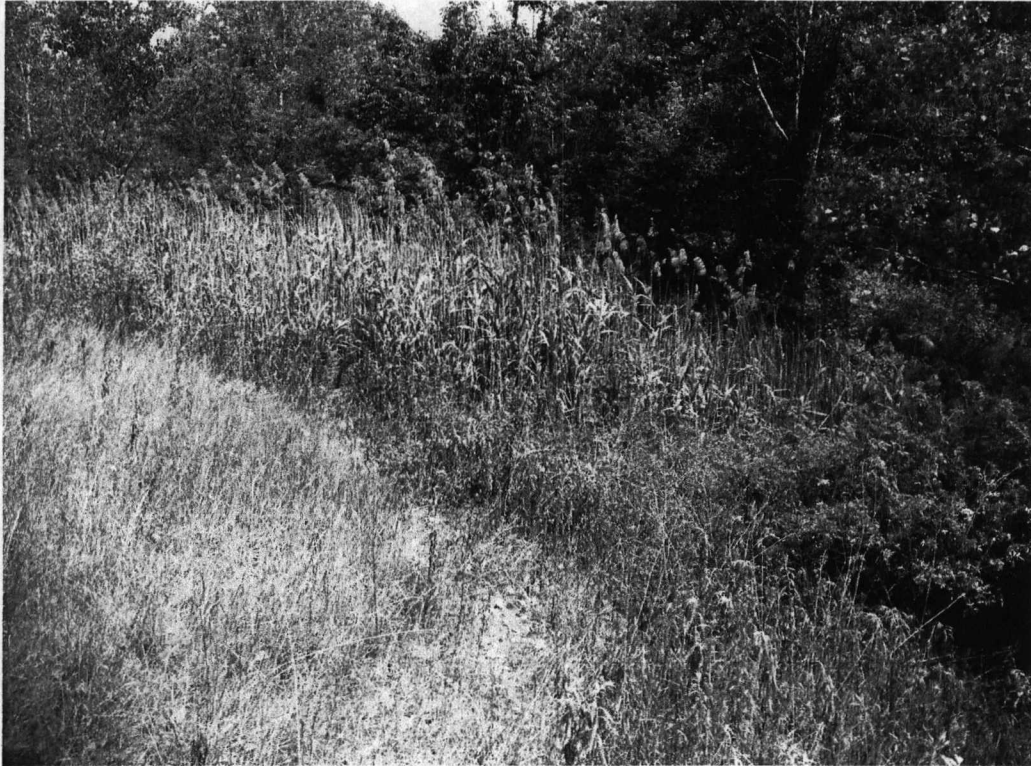
There are many well-established native tree species, particularly locust and cherry. There are also many autumn olive trees (invasive) especially in the south and west of the site. Another invasive species, phragmites, is mainly observed in the east of the site, with some isolated patches of phragmites in the southwest and south-central portion of the site.

One of several areas with *Phragmites*

These observations are documented in the photographic log in Appendix B. The invasive species should be removed from the site and the bird houses straightened. Additionally, overgrown grasses between the landfill and Cleveland Avenue should be mowed.

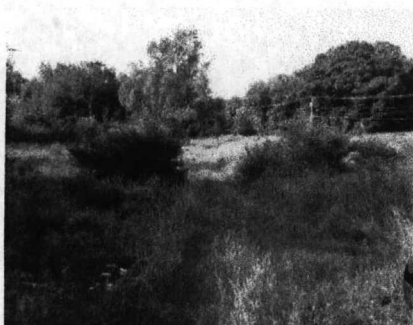
- The area adjacent to Cleveland Avenue and outside the west side of the fence is overgrown with high grass. The grass will be mowed twice a year in May and September.

1. The area outside the fence and adjacent to Cleveland Avenue on the western side of the fence is overgrown with high grass. No garbage was noted in the area. Recommend a mowing frequency of twice a year: May and September.
2. The road leading to the Main Gate is accessible. The Main Gate does have a Restricted Area Sign visible. The sign contains outdated contact information. Ohio EPA is going to change the information to reflect current names and phone numbers. There is a second sign at the northwest corner of the fence.
3. A new padlock was put on the Main Gate and all other perimeter gates. One key opens them all.
4. Fence Line going east on the north side of the fence:
  - a. The north side of the site has areas of excess vegetation that may cause damage to the fence in the future. Recommend that excess vegetation be cut down, if necessary, during May and September mowing activity.

Area outside of fence line adjacent to Cleveland Avenue

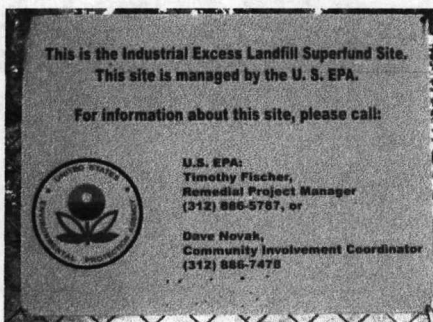
- The Main Gate has a 'Restricted Area Sign' that is visible. It contains outdated contact information. The sign must be updated. Ohio EPA is advising whether or not it is their responsibility to change the sign.

'Restricted Access' Sign on Main Gate

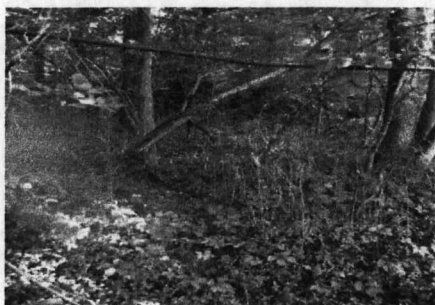
- Excess vegetation was observed on and around the fence between the first gate and the second gate on the north side. Tree branches are resting on a part of

the fence just east of the second gate. The excess vegetation and tree branches will be removed to protect the fence.

Excess Vegetation and Tree Limb on Fence—North Side

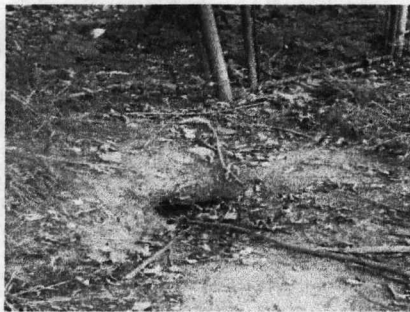
- A gopher hole was observed in front of the first gate on the north side of the fence going east. The hole will be filled in.
- A 10'-15' wide section where the base of the fence does not meet the ground was observed just east of the second gate on the north side. The fence sits approximately 1' above the ground across this section. Soil will be brought in to fill this gap.

b. There is a gopher hole near the first gate going east. Recommend that the hole be filled in.

Gopher hole near first gate going east on north side of fence.

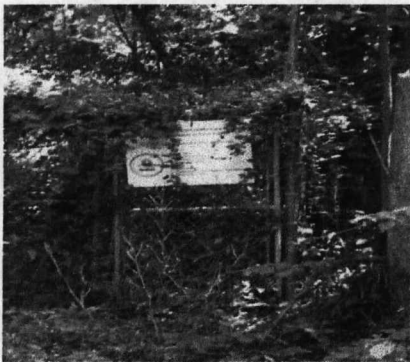
- The southwest corner of the fence has a 'Restricted Area Sign' that is visible. It contains outdated contact information. The sign must be updated. Ohio EPA is advising whether or not it is their responsibility to change the sign.

'Restricted Area' sign on southwest corner of fence.

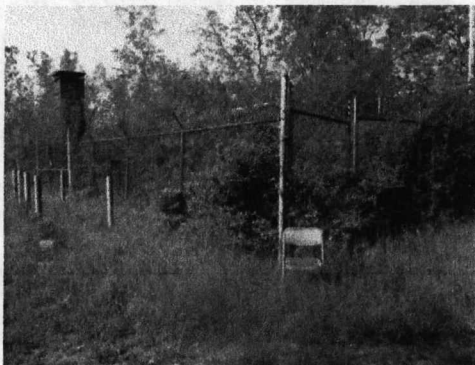
The closed Methane Venting System (MVS) has not operated since 2004. The MVS was inspected and photos were taken. The building was briefly inspected. The structure and the fence around the MVS are in disrepair. The area inside the MVS fence is overgrown with weeds. The US EPA and Ohio EPA Agencies were in agreement that the above ground components of the government-owned MVS, including the building, fence piping and equipment should be demolished pending their approval. It was also agreed that the subgrade components (piping) should stay in place. Soil will be brought in for fill post demolition.

2. The gates all need to have the same key access.
3. The MVS was inspected. Photos were taken. The building was briefly inspected. The structure and the fence are in disrepair. The area inside the MVS fence is overgrown with weeds. The Agencies were in agreement that the MVS above ground components should be demolished. It was also agreed that the below ground (underground) components should stay in place. Extraction wells will be inspected on a follow-up inspection.

5. No change with MVS since May 30 inspection. If above ground piping is taken out, soil will have to be brought in to fill in holes left behind.

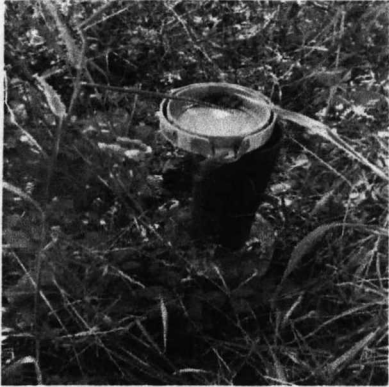
- The latches on the protective outer well casings of MW-3i, MW-7i, MW-7d, MW-11i, MW-11s and MW-11d are broken due to rust and age. These wells cannot be locked. The outer steel casing of MW-7d is also off of its base due to settlement. The MW-11 series wells are located near Cleveland Avenue and are outside of the fenced area on the west side of the site. The protective outer well casings for each of these wells will be repaired, or if necessary replaced.

b. MW-3i needs a new outer cap, it is not locked.

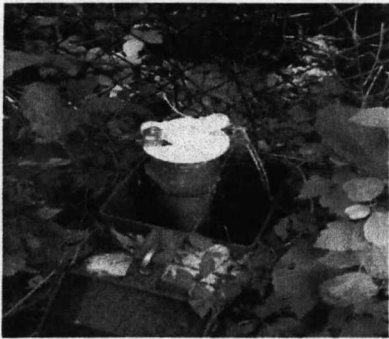
c. MW-7i needs a new outer cap, it is not locked. MW-7d needs a new outer cap, it is not locked. It is also off its base due to settlement.

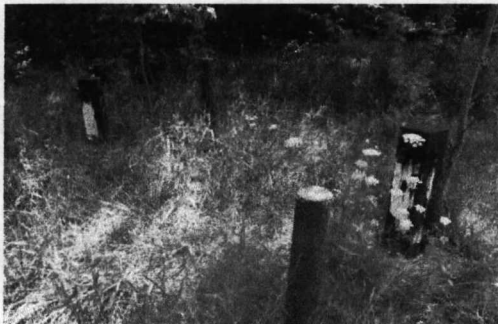
MW-11 series

d. MW-11i, MW-11s, MW-11d all need outer caps. They are not locked.

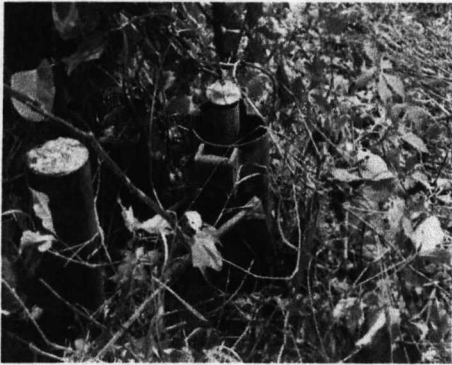
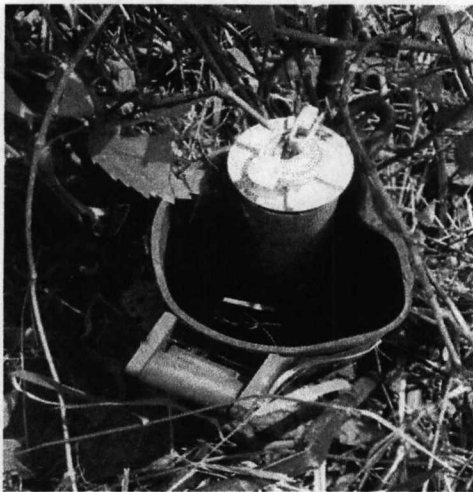
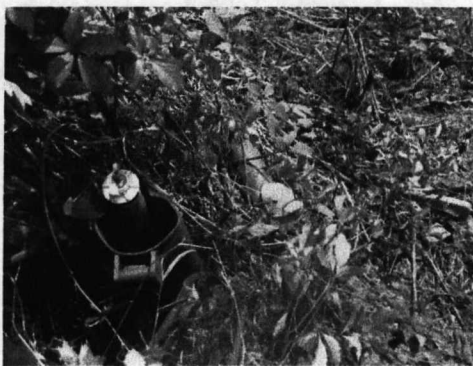
- MW-23s has been hit by a vehicle sometime after May 30, 2012 and before August 3, 2012. It has been knocked over and damaged. The well was hidden from view due to vegetation. Two of its bollards are knocked down to the ground. The protective outer well casing has been knocked off and the well casing has been bent in a sideways direction. This well is located outside of the south side of the fence near an outbuilding. MW-23s will be repaired as appropriate. New bollards will be put in place, which will be taller than the previous bollards in order to improve their visibility.

f. MW-23s needs to be repaired as soon as possible. It sits outside of a work site/garage area. It has been hit by a vehicle since the May 30 inspection. Two of the protective concrete posts are knocked down to the ground. The well itself has been knocked down and the outer cap is completely off.

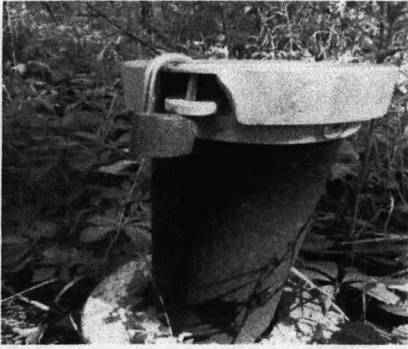
- The outer steel casing of LFG-3 is off of its base and is tilted sideways. LFG-3 is locked.
- The outer casing of LFG-10 has settled and cannot be locked. They are capped with plastic covers. (Each LFG monitoring well is measured at three depths: shallow, intermediate, and deep.)
- The latches on the protective outer well casings of LFG-19 and LFG-23 are broken. They currently cannot be locked. The wells are capped with plastic covers.
- LFG-1 needed a lock, so a lock was placed on outer well cover latch.
- All other wells were inspected and were noted as present. Some of the passive vents are tilted sideways and some extraction wells outer containers are broken, but all are vented and wells themselves are in good shape. Wells that are monitored will be repaired as necessary.

4. LFG-3 is off of its base and tilts sideways. It is locked.

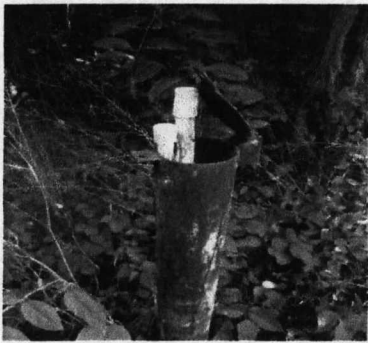
1. LFG-10 cannot be locked, outer casing has settled.

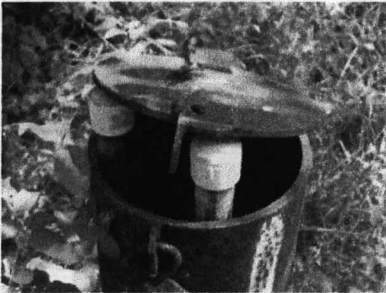
3. LFG-19 needs a new outer cap.

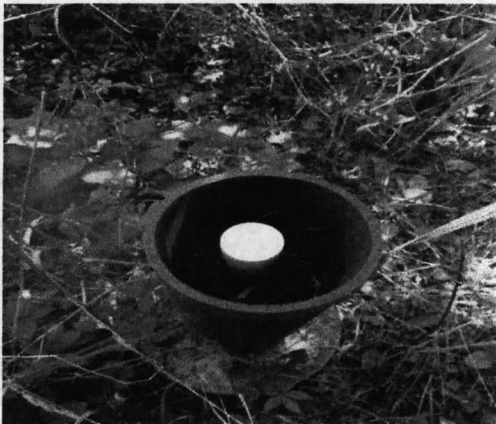
2. LFG-23 does not have an outer cap and is not locked.
